Using Stormwater Runoff For Golf Course Irrigation

Cutten Fields Golf Club
David Kuypers, CGCS, superintendent

Guelph, Ontario

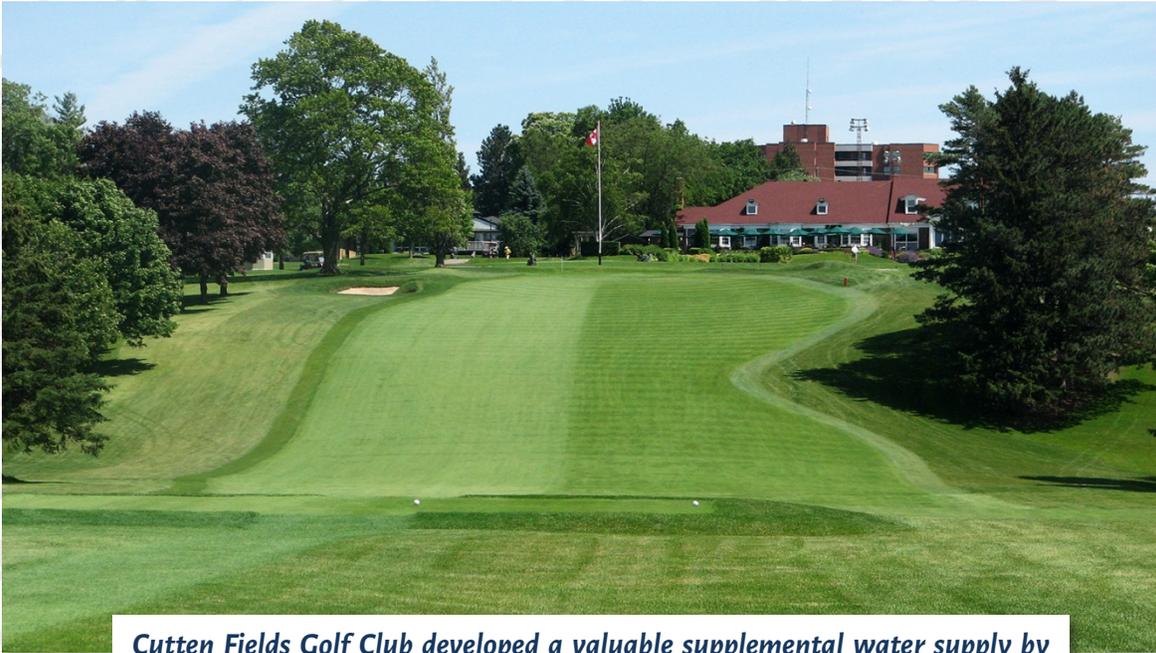
Cutten Fields Golf Club developed a valuable supplemental water supply by connecting to a storm sewer that collected runoff from parking lots and roads.

It was not possible to increase their daily water allotment, so the club undertook an innovative project to capitalize on a unique situation. A storm sewer originating on the University of Guelph campus, located to the south of the golf course, passed beneath the golf course and discharged into the Eramosa River, located to the north. The sewer collected storm water from parking lots and roads on the north end of campus as well as the foundation drains from many of the University buildings. Working in partnership with the University, and with the approval of the local conservation authority, a connection was made to the sewer as it passed through the golf course. This connection would feed a stream that discharged into the golf course irrigation reservoir, providing a valuable supplemental water supply. This extra water would be particularly helpful in times of low-flow or required reductions.

Depending on the level of flow, the connection to the storm sewer can provide 30 - 70 percent of the daily permitted water allotment, meaning that the golf course does not need to pump this water from the Eramosa River. As the club renovated other parts of the facility, including parking lots and the practice range, they connected drainage from those areas to the stream as well. This enabled them to capture even more runoff that could be used for irrigation. In addition to a supplemental irrigation source, the captured runoff also provides steady flow through a golf course water feature, enhancing its aesthetics.
